BODY—WATERLEAK—COWL TO DASH WATERLEAK—WATER ACCUMULATION AND/OR LEAK AT THE DRIVER'S FLOOR PAN AREA	Article No. 02-17-4
--	--------------------------------

FORD: 2002 E SERIES

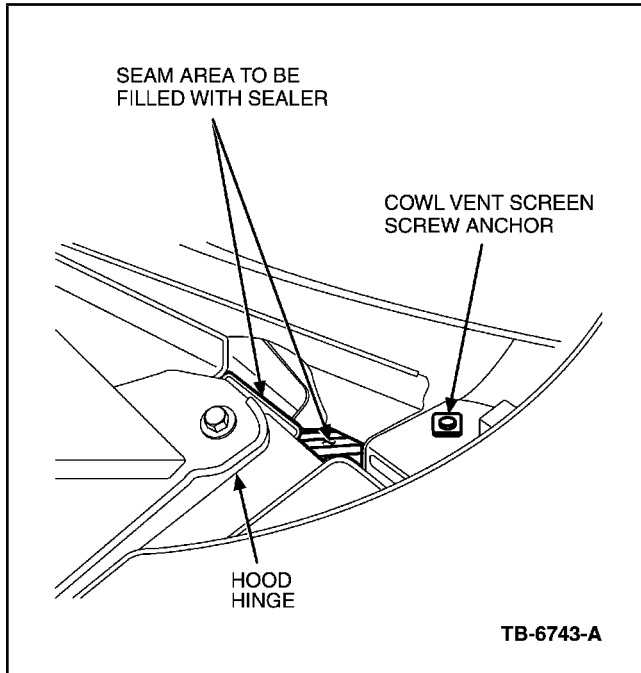
Figure 1 - Article 02-17-4

Some E-Series vehicles built between 12/01/2001 and 5/31/2002 may exhibit a water leak at the driver's side foot well. The leak may occur at the interface between the Cowl and the Dash Panel sheet metal.

6. Apply sealant by placing the tube extension adapter as far down into cowl-to-dash panel seam opening as possible, and pump sealant in along the cowl-to-dash seam until this entire area has been filled (Figure 1). Once water descending from above this seam is diverted, the leak will cease.
